ADDENDUM NO. 1

ROCK RIVER WATER RECLAMATION DISTRICT Dewatering Building Basement Renovations Capital Project No. 1850

ROCK RIVER WATER RECLAMATION DISTRICT DEWATERING BUILDING BASEMENT RENOVATIONS CAPITAL PROJECT #1850

ASBESTOS, THERMAL INSULATION AND LEAD-BASED PAINT INSPECTION REPORT

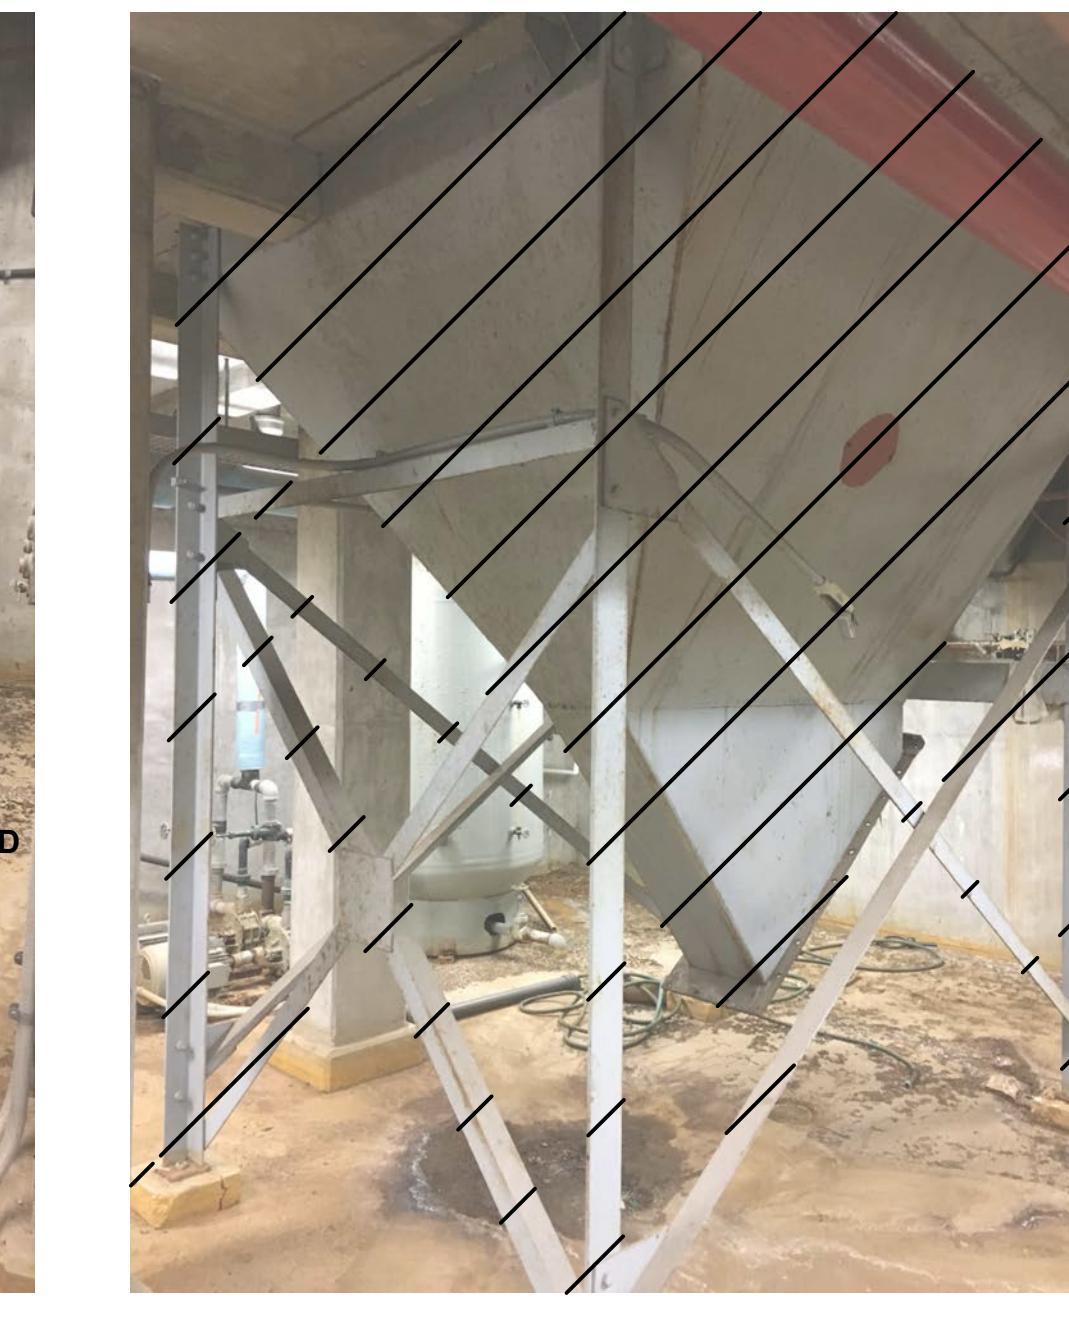
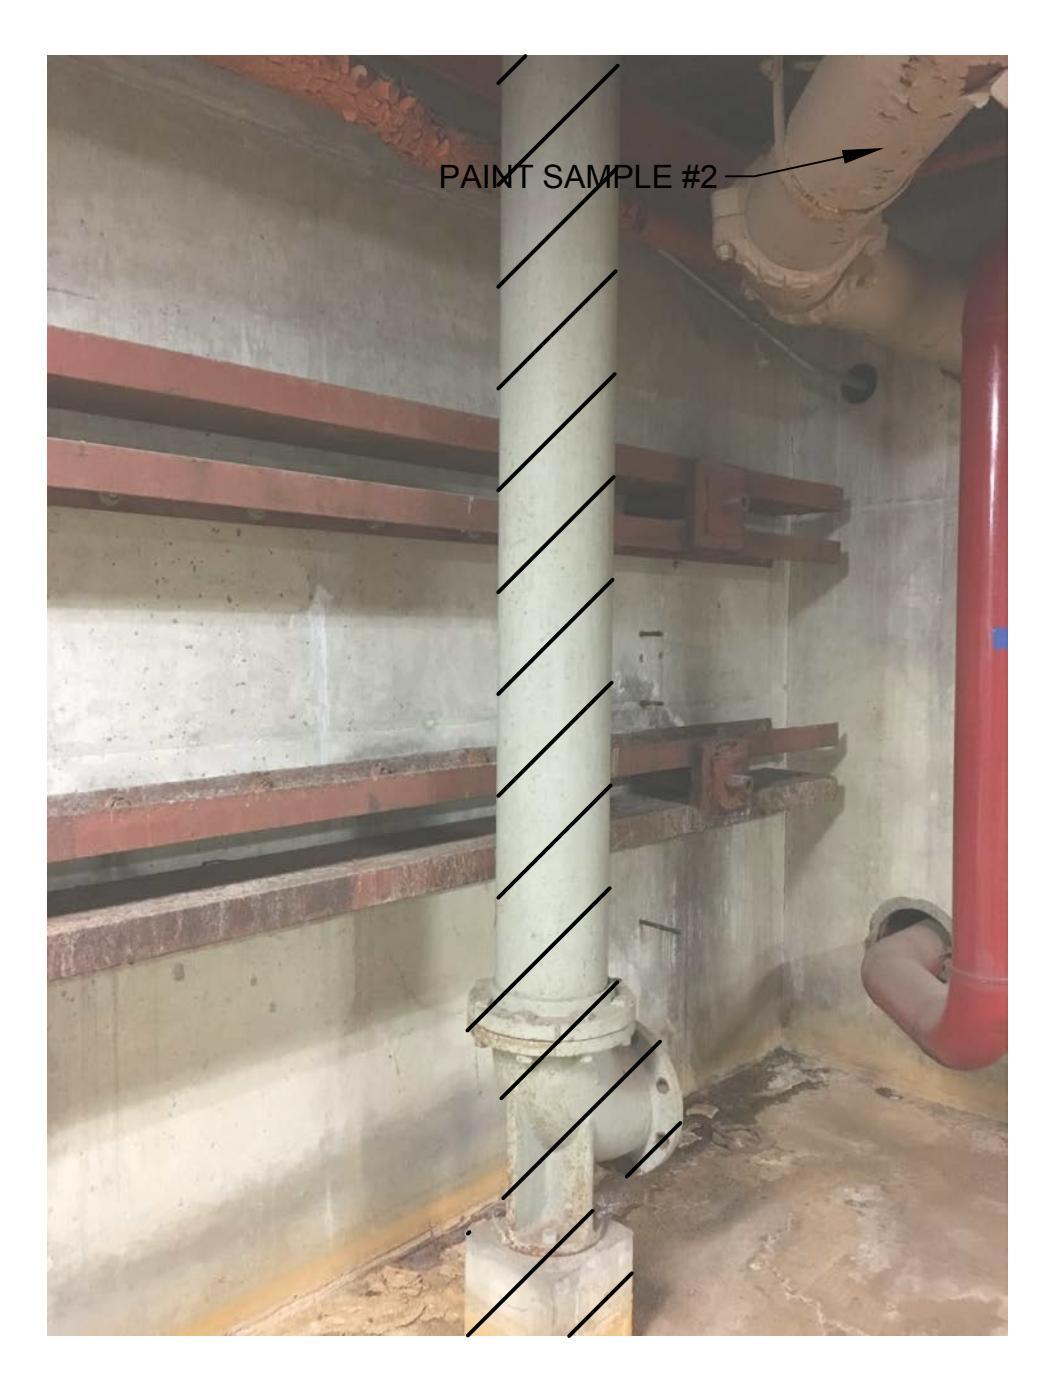
21 REM. HVAC DUCTS & PIPING 4 SCALE: NONE

b. Sheet 7/7 – Detail views have been updated to identify the location of the paint samples that were submitted for lead testing.
